December 1981

THE STREAMBANK EROSION CONTROL
EVALUATION AND DEMONSTRATION ACT OF 1974
SECTION 32, PUBLIC LAW 93-251

Appendix H - Evaluation of Existing Projects

Volume 1 of 2

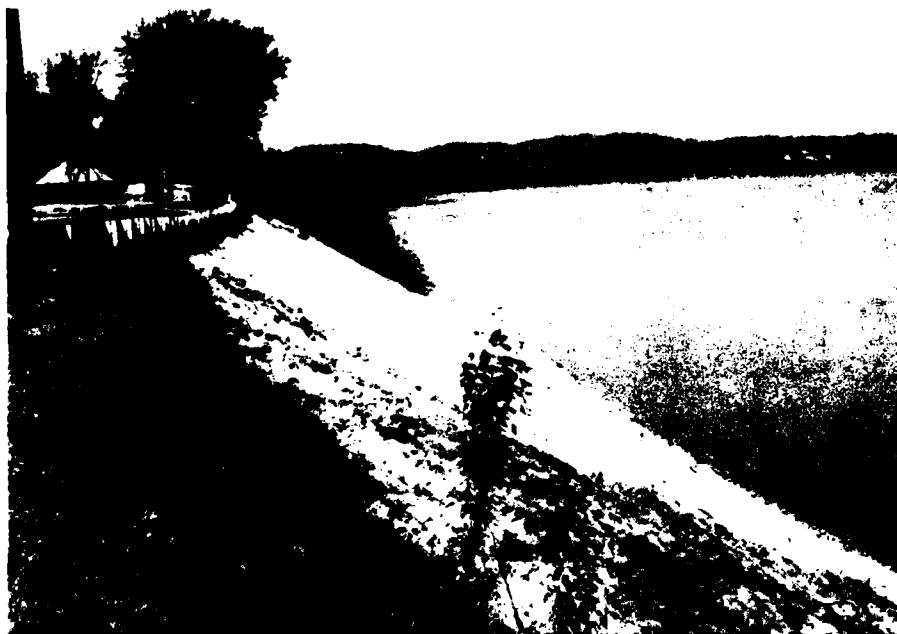
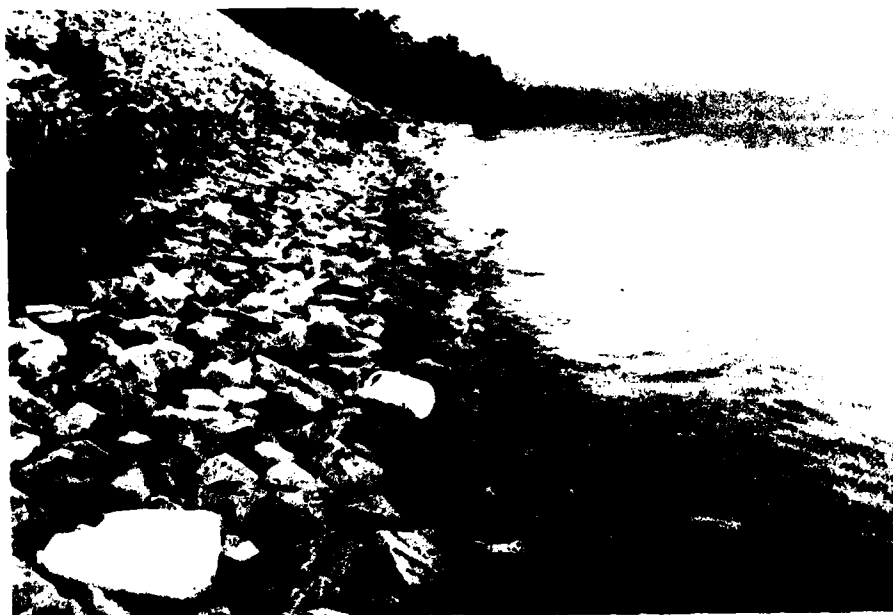
Typical riprap revetment, constructed by the Corps of Engineers
(successful)

Exhibit 4. Ohio River (left bank) at Cloverport, Kentucky. Downstream
view shows toe of revetment under wave attack due to passing barge
traffic (19 June 1978)

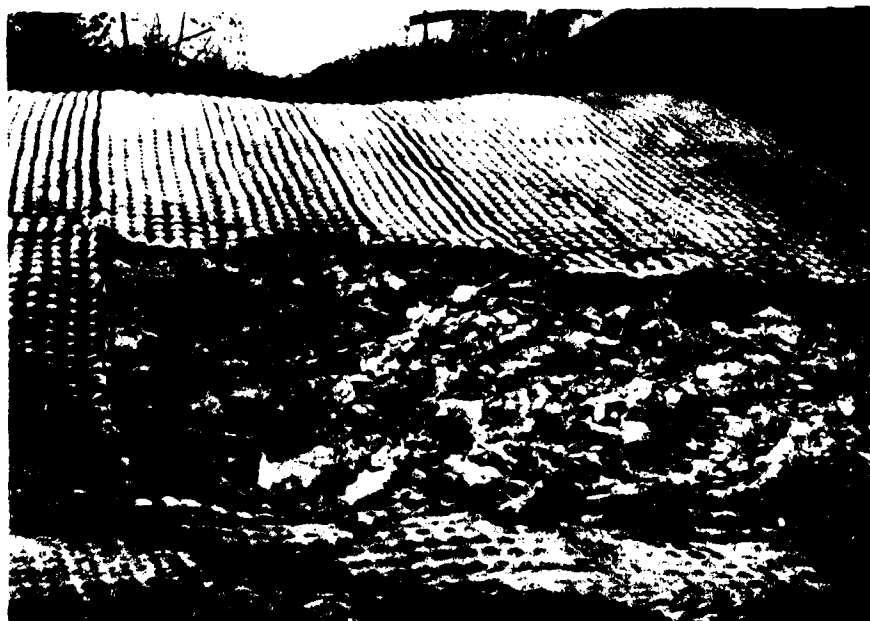
Figure 15. 102 River (East Fork) at Bedford, Iowa. View of damaged Fabriform revetment upstream of the State Street Bridge.

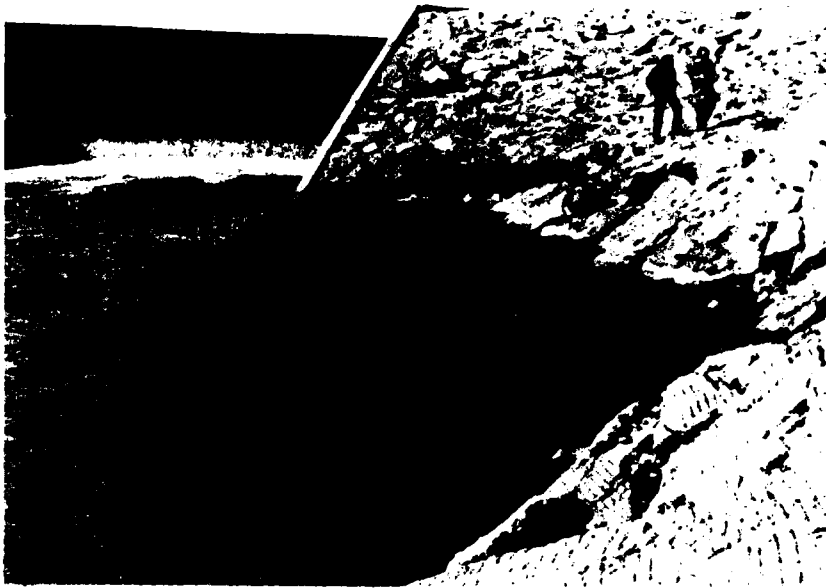
Figure 5. Little Sioux River at Onawa, Iowa. Loss of grout on left-bank mattress

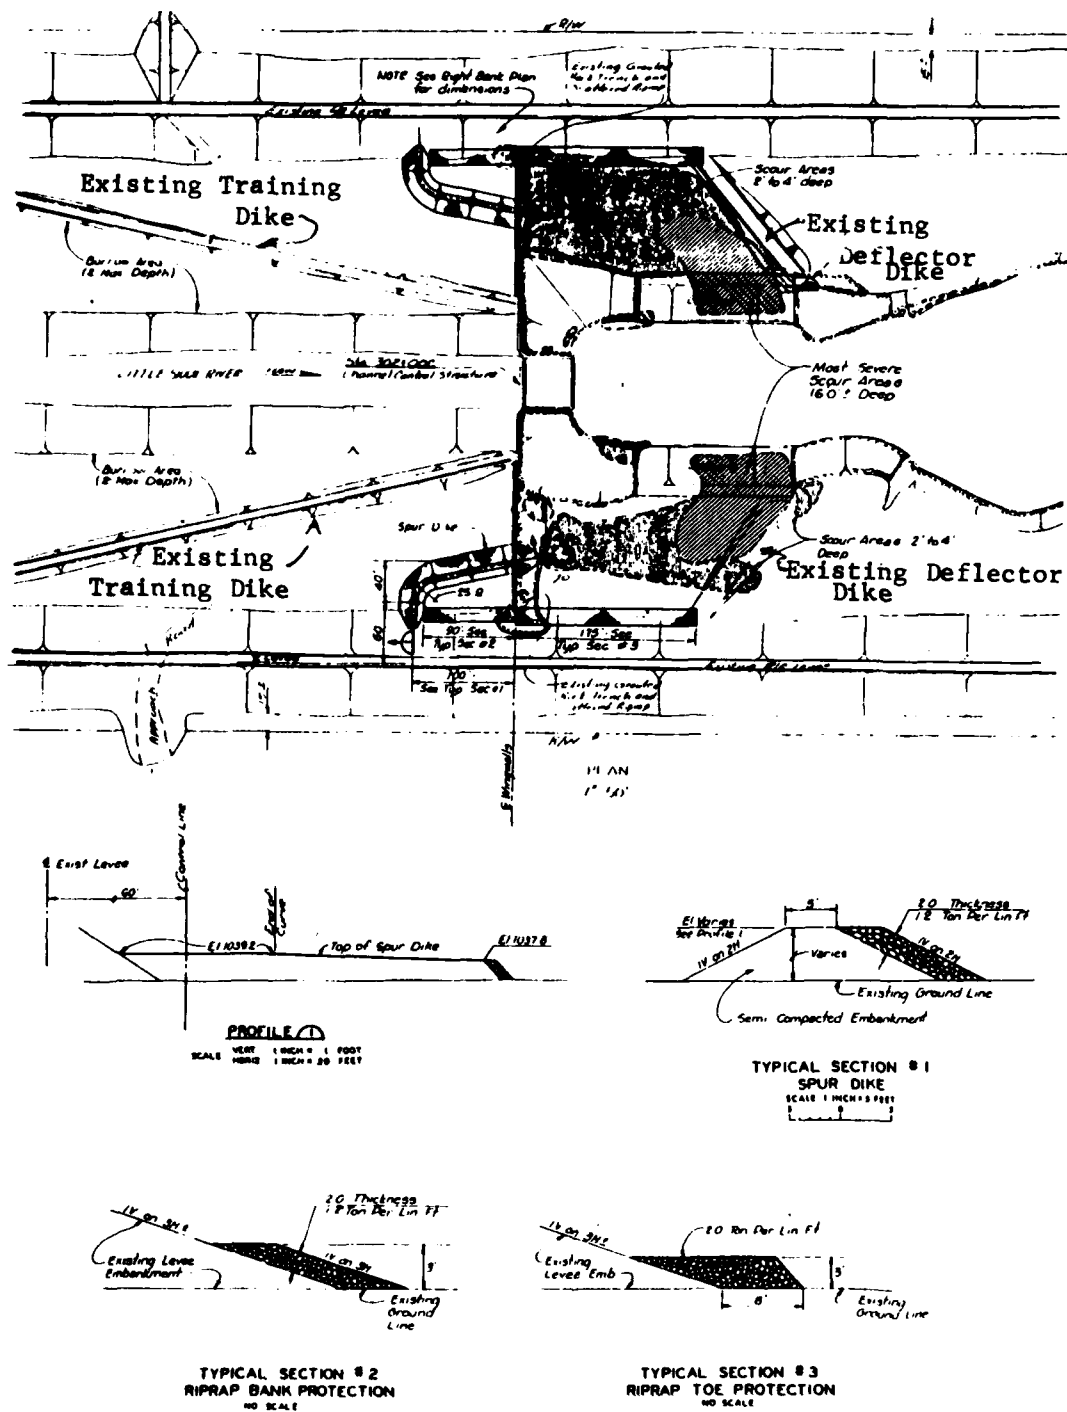
Figure 9. Little Sioux River at Onawa, Iowa. Temporary protection measures (spur dikes) placed in April 1980.

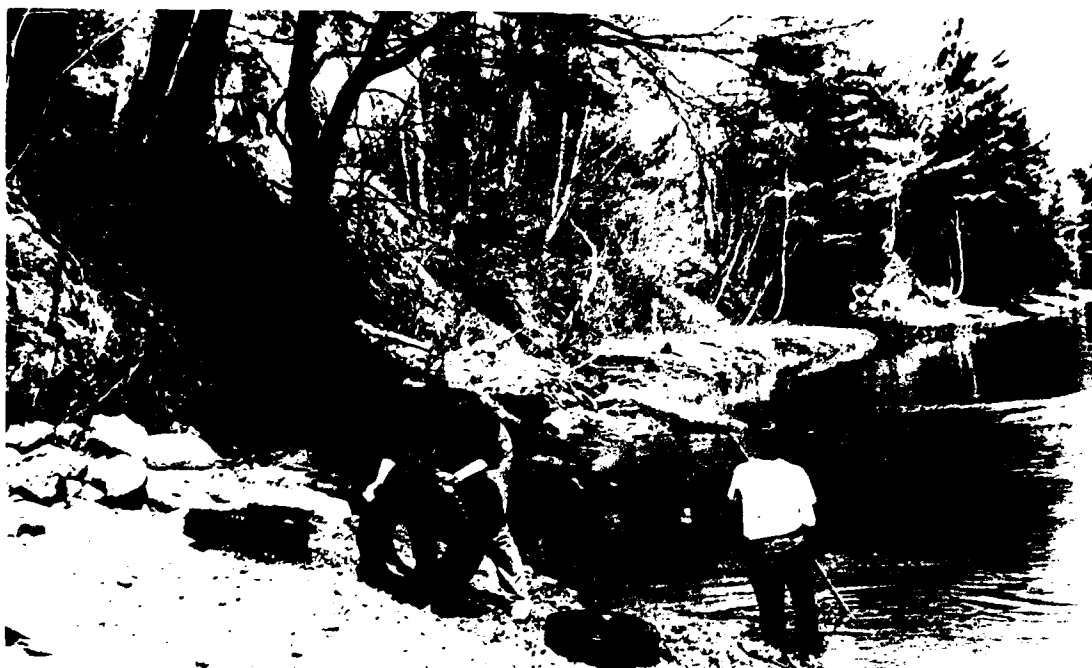
Initiation of used-automobile tire placement in the spring of 1972, Connecticut River at Thetford, Vt. Note eroded bank in background. The Allen residence is located approximately 50 ft landward from the top bank. View is upstream
